DEPARTMENT OF NATURAL RESOURCES
DIVISION OF OIL, GAS AND MINING

RE: Site Inspection, Geokinetics, Seep Ridge Mine, M/047/002, Uintah County, Utah

Date of Inspection: June 27, 2000
Time of Inspection: 1040 - 1450
Conditions: Partly cloudy, warm
Participants: Mickey Schott and Tom Concannon, Geokinetics; Tony Gallegos, DOGM

Purpose of Inspection: To examine the last reclamation performed at the site and also determine the reclamation remaining to be completed.

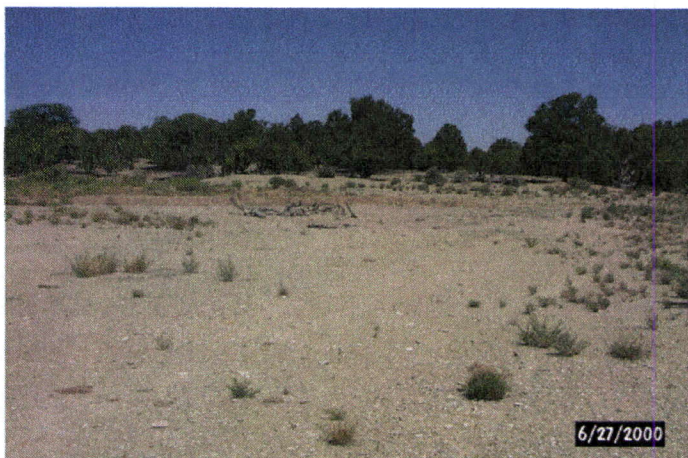
TAUK BATTERY

The first area visited was tank battery #1. In this area all the equipment has been removed leaving only a flat earthen pad. Final reclamation of this area would include deep ripping to relieve compaction and seeding. The ripping would also make this area less attractive for vehicles to travel on while vegetation is being re-established. A photograph of this area shows the generally barren pad area and the adjacent vegetation.

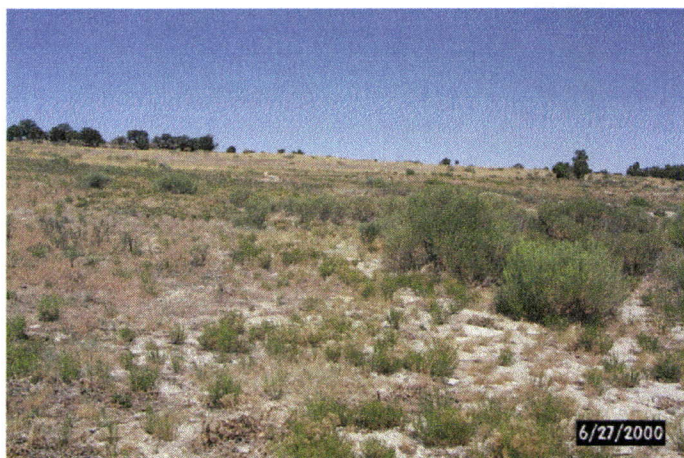
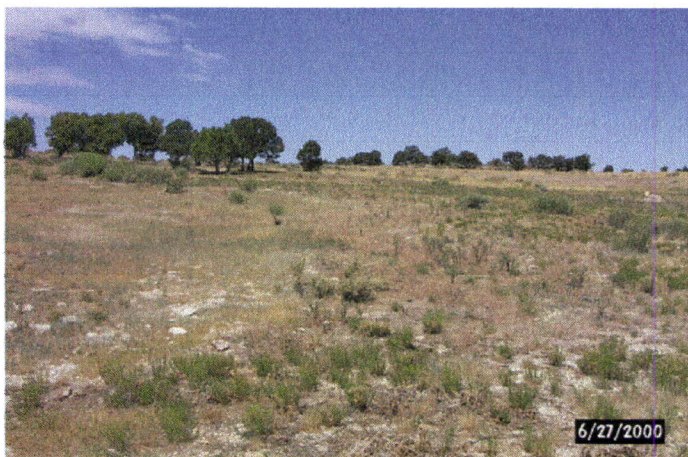
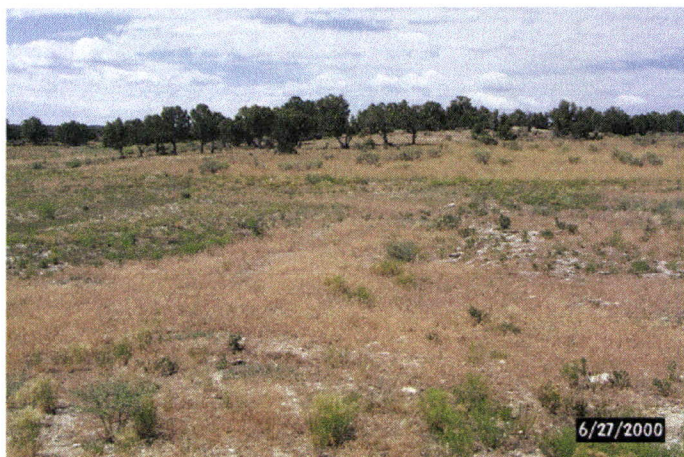
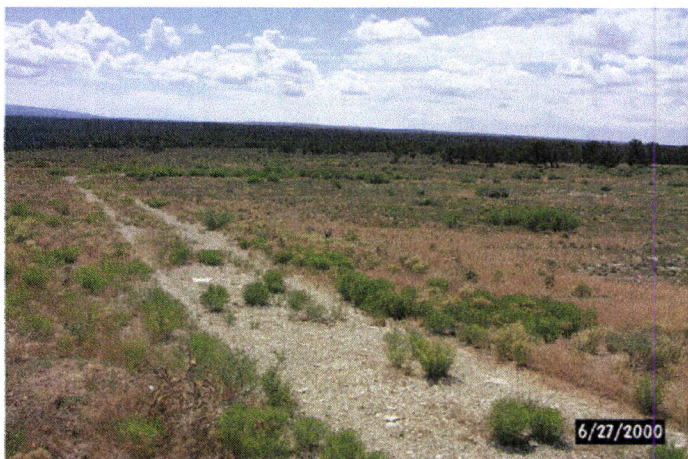
CAMP

The next area visited was the camp area. The camp area contained little visible debris. Several pads for trailers parking were still visible as leveled areas with lesser amounts of vegetation. Some of these pad areas are visible in the photographs. A road through the trailer camp still exists. There is a fair amount of vegetation established throughout the camp area due to reclamation seeding or natural invasion over the long time period of inactivity. Given the extent of the natural revegetation, it may not be desirable to regrade or rip this area and then reseed. The existing vegetation cover will need to be considered in evaluating additional reclamation in the camp area. Division files will also need to be reviewed to determine if this area has been released yet. Photographs were taken to document the amount of vegetation in this area.

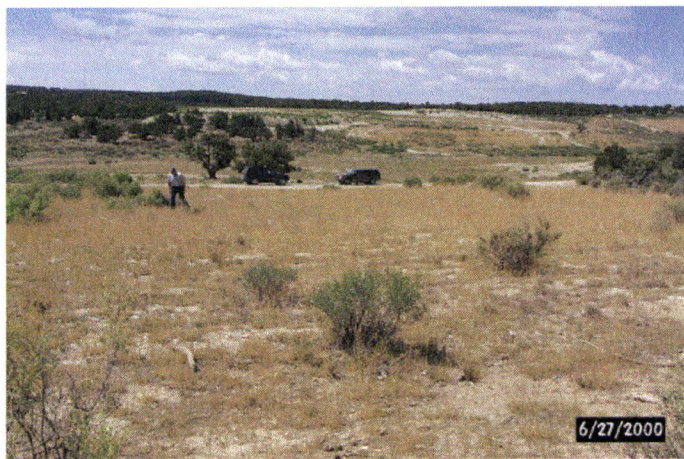
P-1 AREA

The next area visited was the site of the P-1 Monitoring Wells. We could not find these wells, but from the map it appeared that P-1 was located within an area which had already been reclaimed. The Division's 4/12/96 inspection memo mentioned that this well had been plugged. Photographs of the

reclaimed area were taken looking south with the two vehicles facing each other on the road in the background. This area may be eligible for final reclamation release if the vegetative cover meets the success standard.

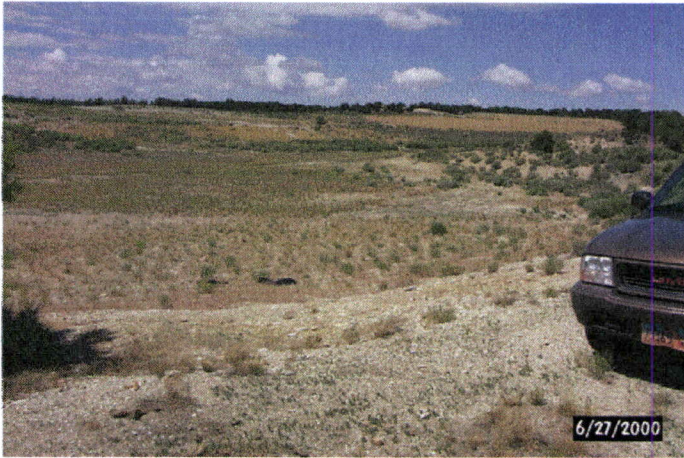
SHOP AREA

The next area visited was the road above the shop. It was unclear whether the shop area had been seeded, or if it actually needs to be seeded. Division files will need to be reviewed, and the Minerals biologist consulted regarding seeding of this area. Photographs of the shop pad were taken looking toward the southwest with a portion of the state vehicle in view.

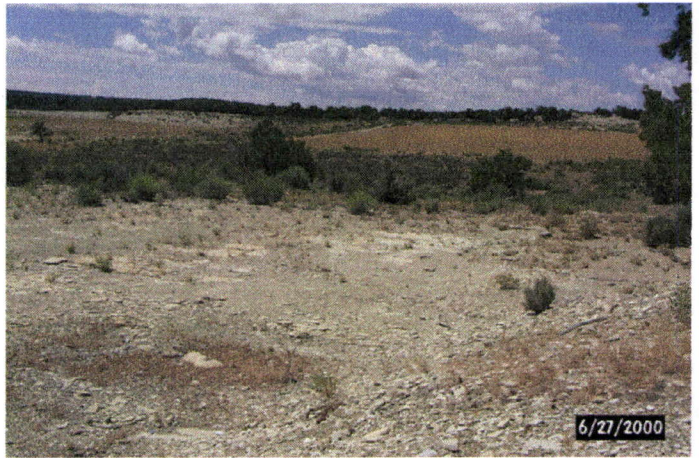
OFFICE AREA

The next area visited was the office area. Photos of the office site were taken looking toward the southeast. In these photos will be what appears to be a degraded concrete pad, but this is actually the rock outcrop on the surface. This rock outcrop may need to be ripped, but ripping may cause more harm than good, depending on the adjacent vegetation, or depending on what is expected to grow in this outcrop material.

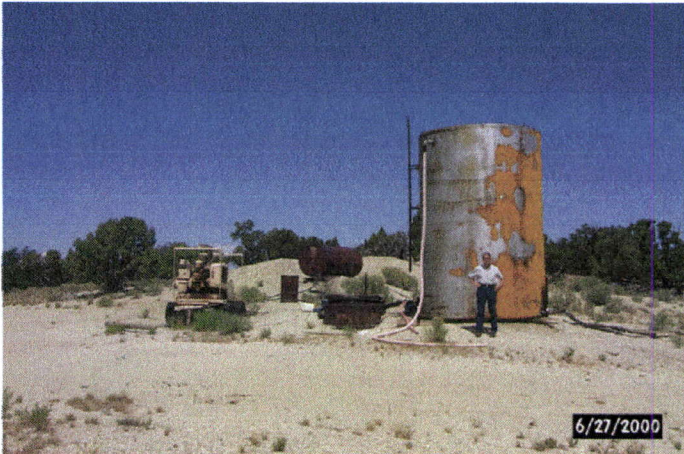
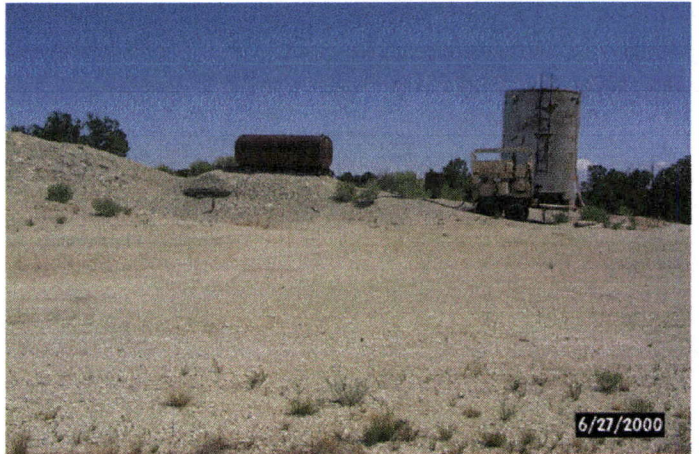
WATER WELL

We next visited the nearby water tank, or the water well location. A standing tank is still present here. This tank was empty, but the valves connecting to the pump appear to be fairly new, meaning someone has been using the well, or intends to use this well in the immediate future. A generator and fuel tank are also located in this area. The soil beneath the generator has been saturated with fuel or oil from refueling spills or leaks.

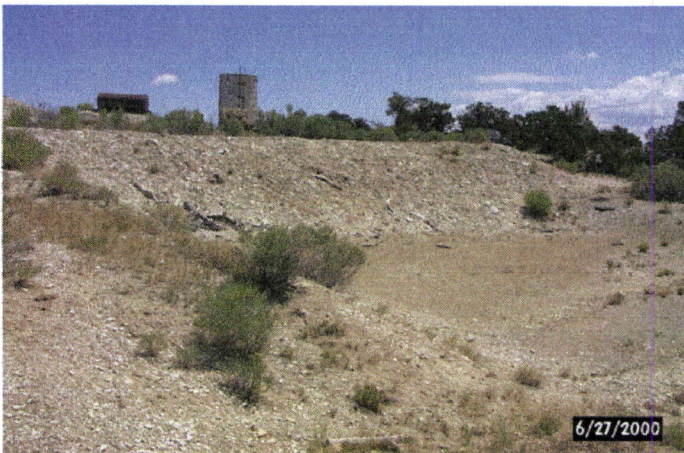
T SHAPED EXCAVATION

The next area examined was the nearby "U" shaped excavation west of the office area. Final reclamation would include regrading this excavation and revegetating the area. Photographs were taken of this excavation showing the location in relation to the water tank.

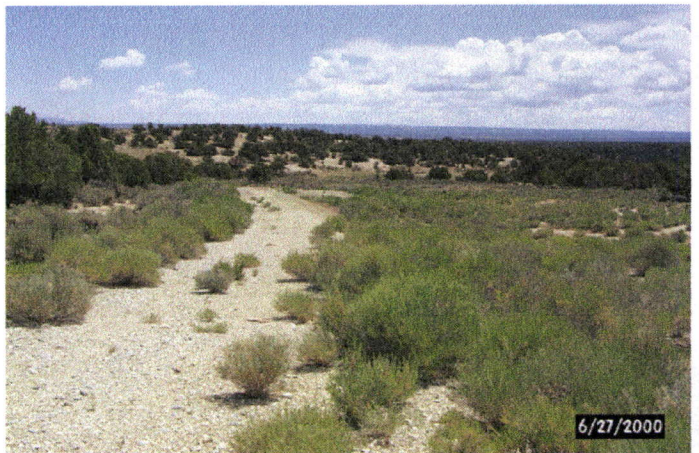
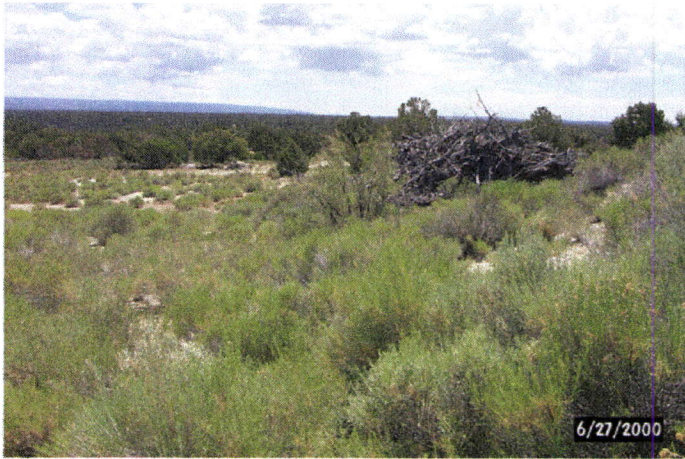
LANDFILL

The next area examined was the landfill. The 4/22/96 memo mentioned that the remaining portion of the access road past the sanitary landfill will need to be regraded. The memo also mentioned that the pad area southwest of the nearby Tank Farm #2 will also need to be regraded, ripped and seeded. A majority of the landfill area looks undisturbed, or looks like it has been unaffected for some time, based on the invasion of natural vegetation. There is a road remaining around the landfill with a pile of grubbed vegetation on one side. The pile of grubbed vegetation is a visible attractant and a fire hazard. Ideally, this material would be spread out over reclaimed areas to increase the organic content and help naturalize the area visually. The reclamation plan will need to be reviewed to see what other work was expected to be done here.

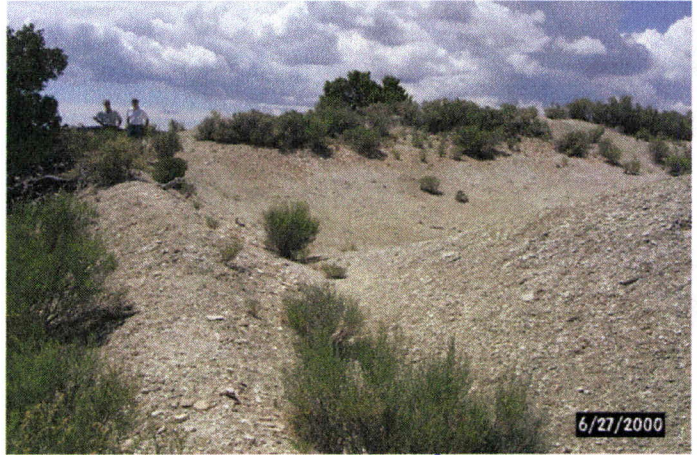
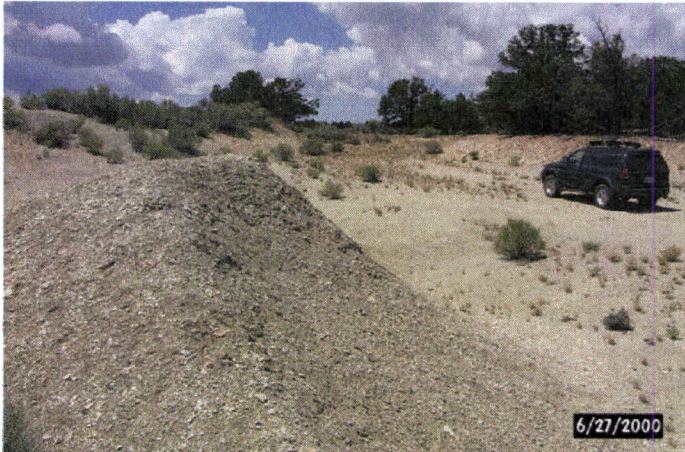
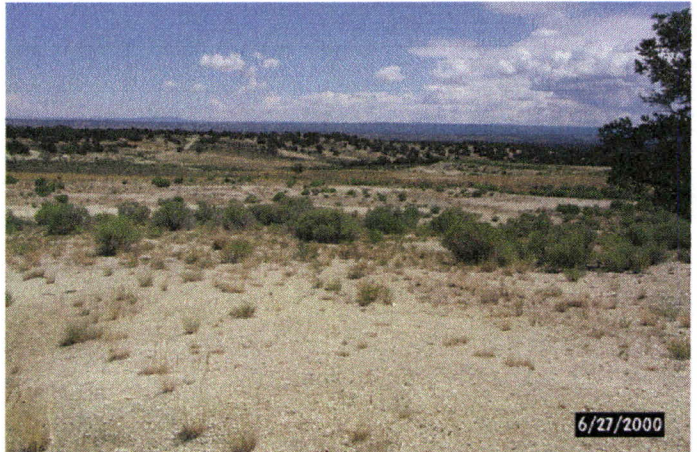
PILES NEAR TOPSOIL

The next area examined was a nearby pile of material. This material was possibly used as road base throughout the site, or maybe as an overburden replacement material. Final reclamation would include regrading these piles to blend in with the natural contours and then seeding the regraded area. Photos were taken from this vantage point of the general site looking toward the northeast to the east with the water tank visible in the distant background.

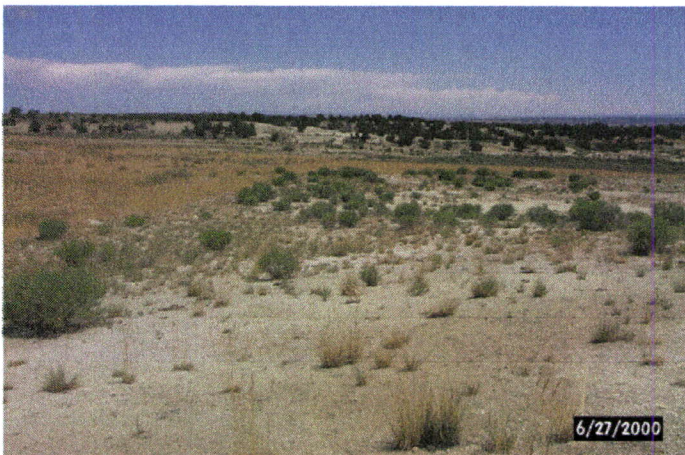
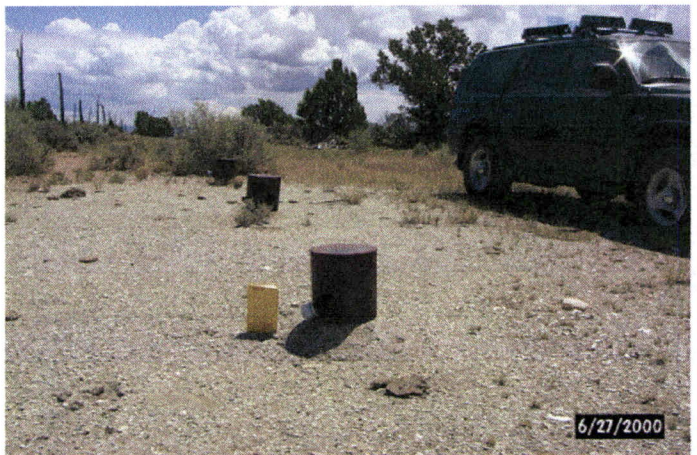
We next went to the P-2 Well site. At this site there were three pipes or three wells with metal caps over them. Two of the metal caps are locked and the other cap is in place, but unlocked. Reclamation of these and the other wells would include the appropriate plugging or decommissioning of the monitoring wells by excavating below grade to expose the casing, cutting that casing off, plugging the well with concrete or grout as required, and then backfilling the excavation to the surface, and possibly leaving a monument at the surface where the well is located. It's possible that these wells need to be decommissioned or closed in a very specific manner, depending on whether the wells were set up for groundwater monitoring, or for retort operations.

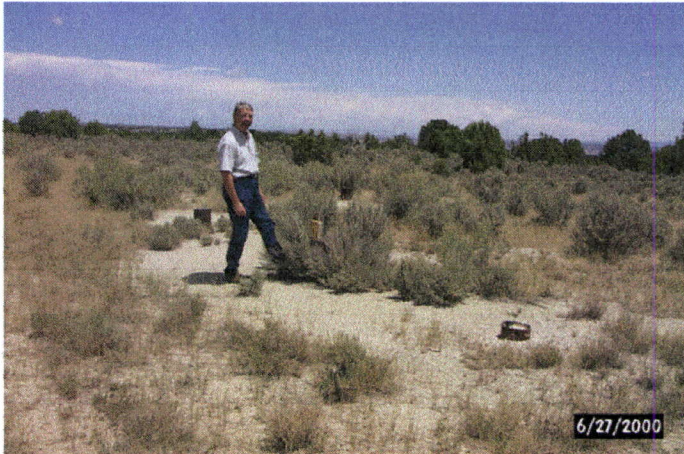
The next area visited was the P-4 Well site. This site is along the main county road. At this site were three metal covers over the wells. One of the covers was unlocked. Photographs of these monitoring wells includes Mickey Schott standing near the well casing with a yellow field book

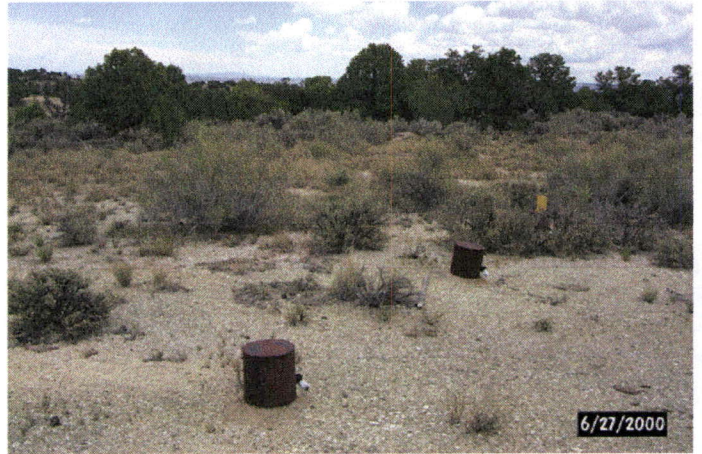
The next area examined was the P-3 Well site. We had some difficulty finding these wells. Photographs were taken of the three wells with the locked covers. A yellow field book was placed on the most distant well cover.

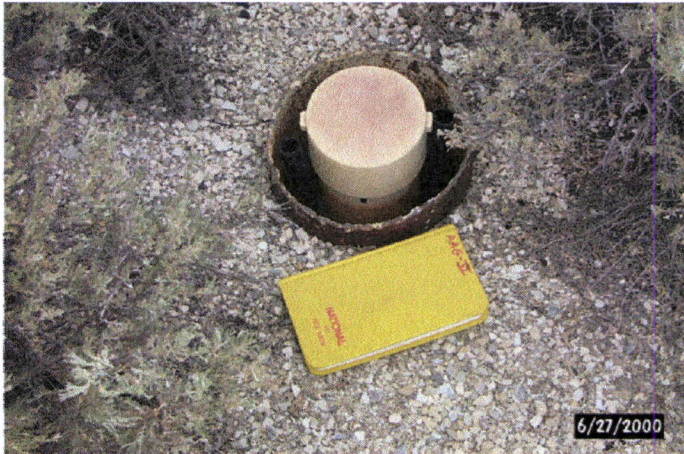
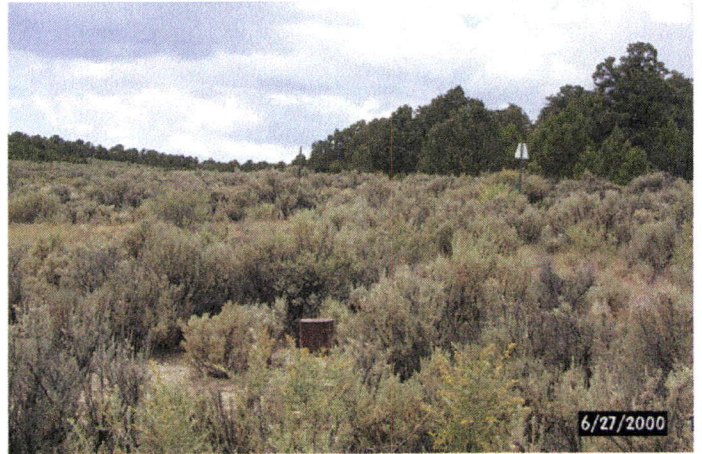
We then went to the P-6 Well site. At this monitoring well site were two wells with locked metal covers and one well without a locked metal cover. The well without a metal cover did have a plastic cap over the top of the well casing.

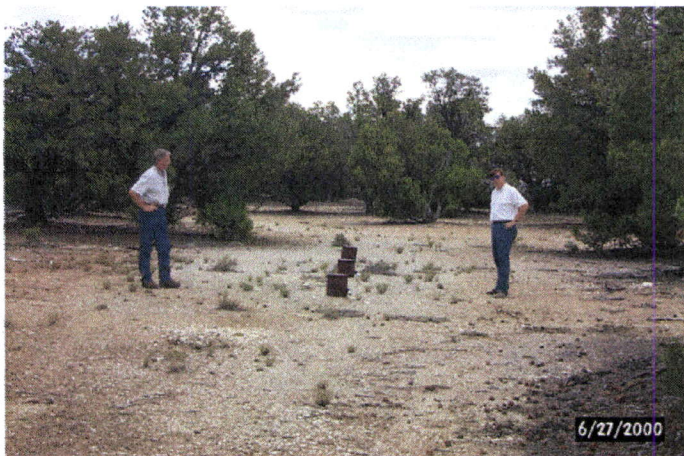
The next area visited was the P-5 Well site. We had difficulty finding the access road to the P-5 Wells. This site can be accessed by driving north along the natural gas pipeline east of the P-5 site, and then walking up to the site.
